# Ecological Surveys of Welsh Lakes 2016

Shilland EM<sup>1</sup>, Goldsmith B<sup>1</sup>, Hatton-Ellis TW.

NRW Evidence Report No. 204

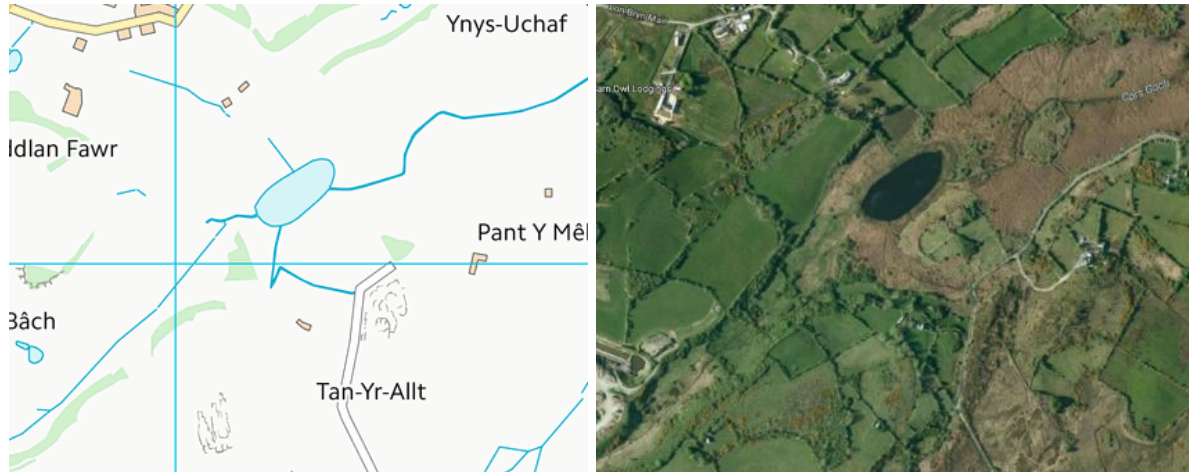
Figure 2. Site map and aerial photograph of Llyn Cadarn.

Llyn Cadarn is a very small (1 ha), shallow (mean. depth 4.6 m) high alkalinity lowland lake located on the Isle of Anglesey, North Wales. It lies within the Cors Goch SSSI and NNR and Corsydd Môn/ Anglesey Fens SAC. The catchment is predominantly improved grassland but the lake itself sits in an alkaline fen and is surrounded on all sides by reeds, in an assemblage dominated by *Typha*

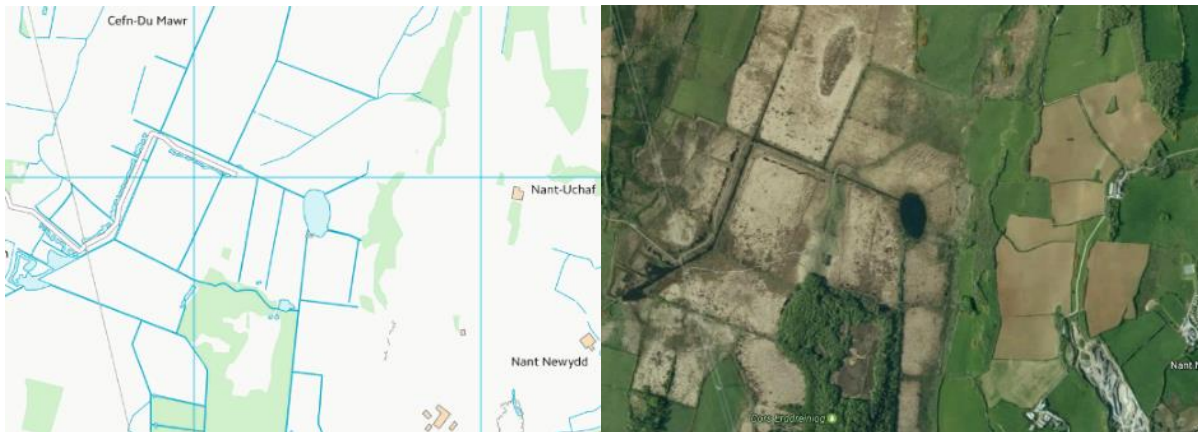
Figure 5. Site map and aerial photograph of Llyn yr Wyth Eidion.

Llyn yr Wyth Eidion a very small (1 ha), moderately shallow (mean depth 6 m) but steeply shelving lowland glacial kettle-hole lake located on the Isle of Anglesey, North Wales. It forms part of the Cors Erddreiniog NNR and SSSI and Corsydd Môn/ Anglesey Fens SAC. Similar to the nearby Llyn Cadarn, the catchment is predominantly improved grassland but the lake itself sits in an alkaline fen.

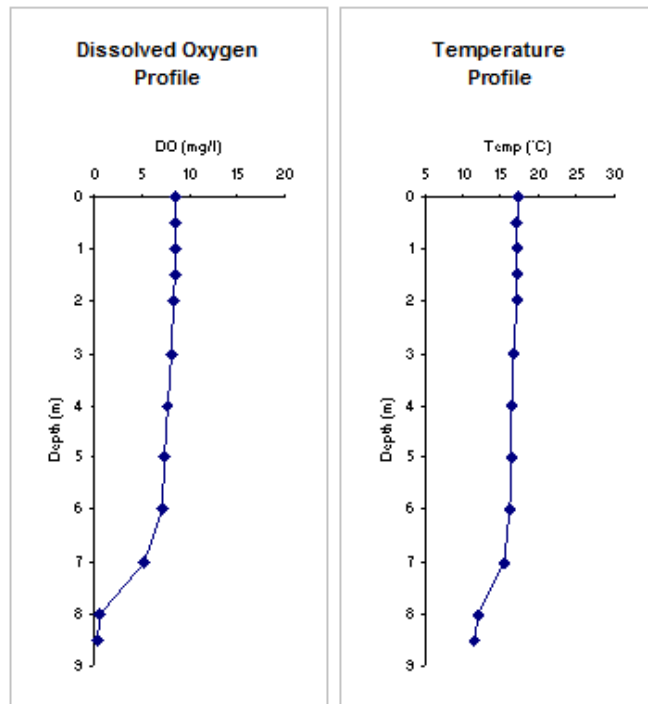
Dissolved oxygen and Llyn yr Wyth Eidion temperature profiles show the lake to be stratified during summer with a thermocline at approximately 6.5 m, below which temperatures fall to 11.6 °C. Dissolved oxygen concentrations also fall to nearly zero by the bottom of the profile (Figure 7). This thermal stratification at the site was also observed by Monteith (ed.1997).

Depth (m)	DO (mg/l)	Temp (°C)
0	8.5	17.3
0.5	8.47	17.2
1	8.46	17.2
1.5	8.47	17.1
2	8.32	17.1
3	8.19	16.7
4	7.73	16.5
5	7.31	16.3
6	7.18	16.1
7	5.3	15.4
8	0.62	12.1
8.5	0.38	11.6

Figure 7. Dissolved oxygen and temperature profiles at Llyn yr Wyth Eidion (14/09/2016).

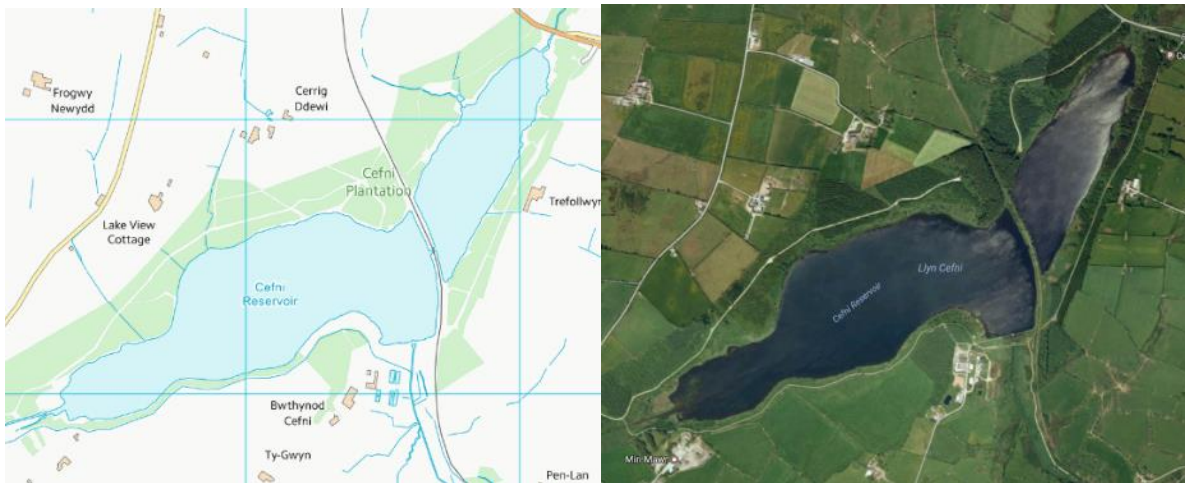
Figure 8. Site map and aerial photograph of Cefni Reservoir.

Cefni Reservoir is a large (68 ha), shallow (max. depth 4.5 m) lowland reservoir located on the Isle of Anglesey, North Wales. It is owned by Dŵr Cymru / Welsh Water and was constructed in 1940s to improve the water supply to the island. The reservoir is separated into two parts by the causeway of an abandoned railway line, although an opening allows the exchange of water between the two sections. Cefni Angling Association is based near the dam and members fish for wild brown trout and stocked rainbow trout from both boats and the shore. The large catchment is dominated by agriculture, primarily improved grassland but with some calcareous grassland and arable horticulture. There are also areas of broadleaved and coniferous woodland, some of which surround much of the perimeter of the site itself.

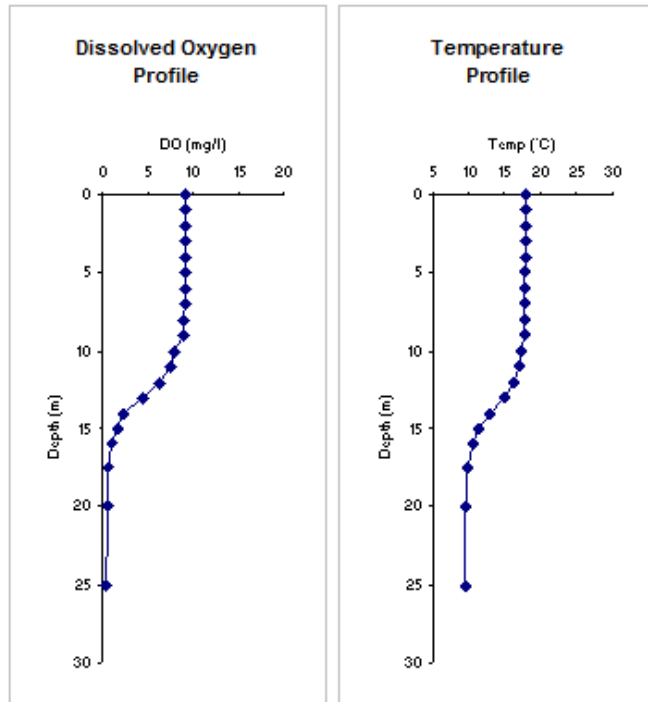
Depth (m)	DO (mg/l)	Temp (°C)
0	9.22	17.9
1	9.24	17.9
2	9.24	17.9
3	9.22	17.9
4	9.18	17.9
5	9.16	17.8
6	9.13	17.8
7	9.11	17.8
8	9.06	17.8
9	8.97	17.7
10	8.04	17.3
11	7.54	16.9
12	6.33	16.2
13	4.51	14.9
14	2.33	13
15	1.66	11.5
16	0.95	10.5
17.5	0.52	9.9
20	0.56	9.7
25	0.5	9.7

Figure 13. Dissolved oxygen and temperature profiles at Llys-y-Fran Reservoir (16/09/2016).

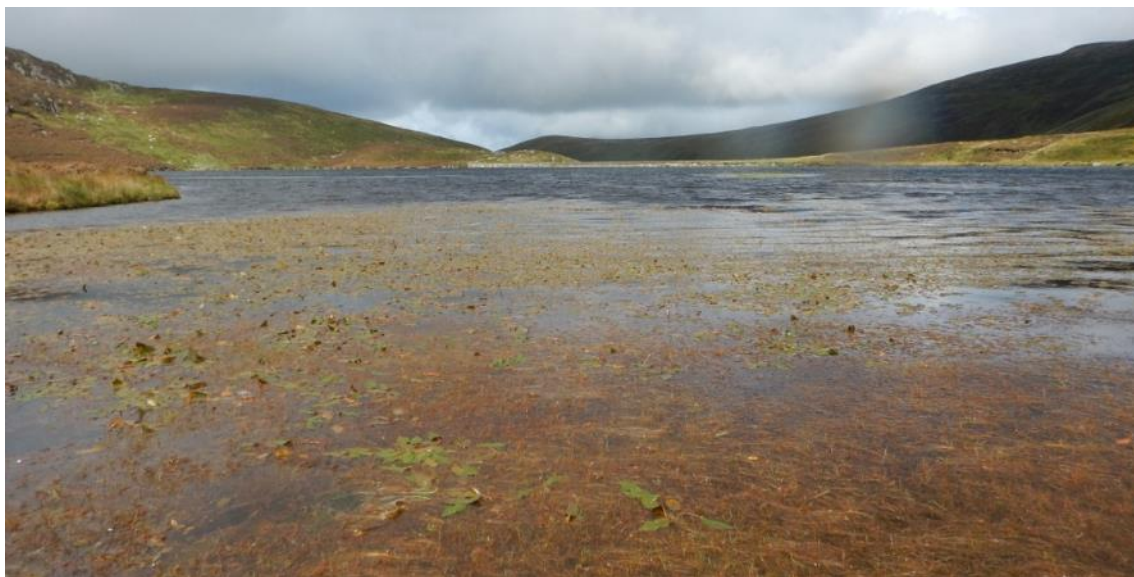
Figure. 15 Llyn Anafon site photo; from the south end looking north-west.

Llyn Anafon is a small (4 ha), mid altitude lake with a maximum depth of 10.5 m located in Gwynedd, North Wales. A dam, built in 1929 to provide a water supply, maintains water levels at around 1.5m higher than the original lake. The site is surrounded by moorland, and falls within the Eryri SSSI, Eryri/Snowdonia SAC and the Snowdonia National Park.

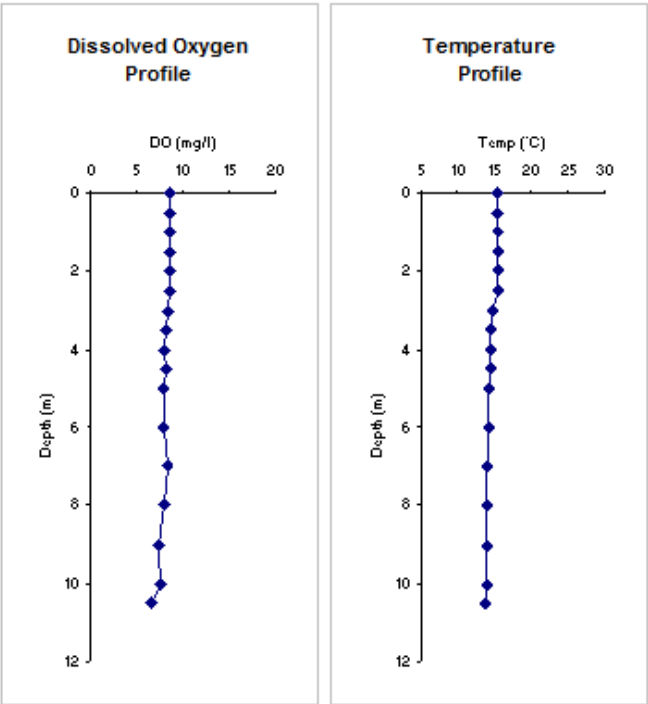
Depth (m)	DO (mg/l)	Temp (°C)
0	8.56	15.4
0.5	8.63	15.4
1	8.66	15.5
1.5	8.66	15.5
2	8.69	15.5
2.5	8.69	15.5
3	8.49	14.7
3.5	8.2	14.5
4	8.07	14.5
4.5	8.22	14.4
5	7.94	14.3
6	8.04	14.2
7	8.43	14.1
8	8.02	14
9	7.39	13.9
10	7.53	13.9
10.5	6.58	13.8

Figure 16. Dissolved oxygen and temperature profiles at Llyn Anafon (16/09/2016).

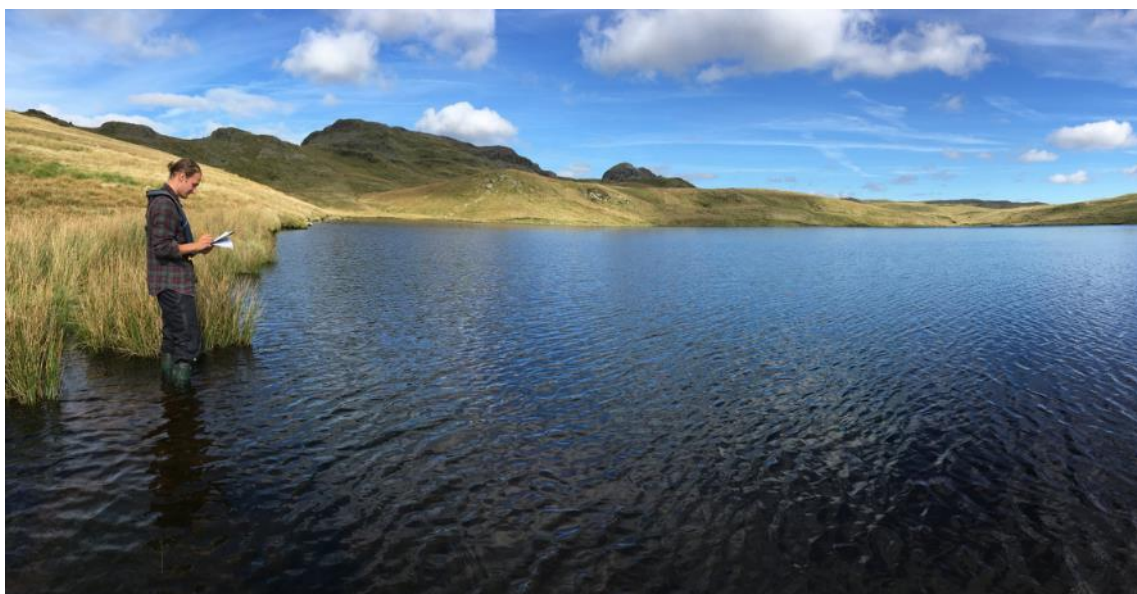
Figure 18. Llyn Morwynion site photo; from the north-west shore looking east.

Llyn Morwynion is a small (11 ha), generally shallow (mean. depth 5.5 m) oligotrophic, mid altitude lake located in Gwynedd, North Wales, and lies within the Snowdonia National Park. It is owned by Dŵr Cymru / Welsh Water and has been dammed and raised to provide a drought protection reservoir. A fishing club stock the site with rainbow trout. The lake is surrounded by acid grassland with some heath and bogs.

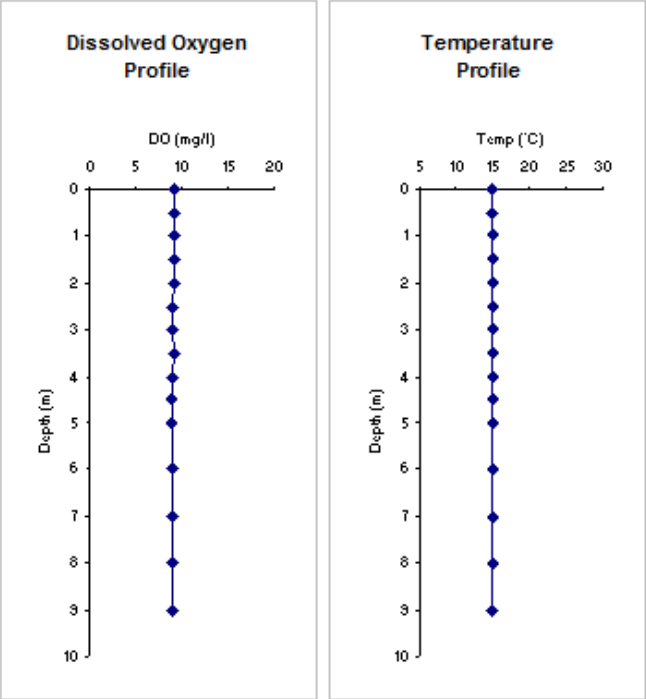
Depth (m)	DO (mg/l)	Temp (°C)
0	9.13	15.1
0.5	9.13	15.1
1	9.11	15.1
1.5	9.11	15.1
2	9.11	15.1
2.5	9.08	15.1
3	9.08	15.1
3.5	9.1	15.1
4	9.09	15.1
4.5	9.05	15.1
5	9	15.1
6	9.04	15
7	9.02	15
8	9	15
9	9	14.9

Figure 22. Dissolved oxygen and temperature profiles at Llyn Dwythwch (18/09/2016).

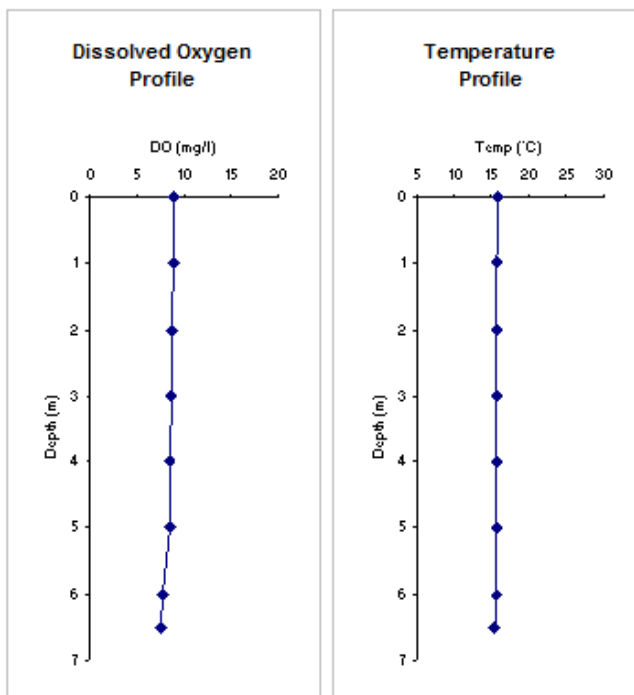
Depth (m)	DO (mg/l)	Temp (°C)
0	8.93	15.9
1	8.93	15.8
2	8.83	15.8
3	8.7	15.7
4	8.59	15.7
5	8.55	15.6
6	7.69	15.6
6.5	7.63	15.5

Figure 25. Dissolved oxygen and temperature profiles at Llyn Eiddwen (19/09/2016).

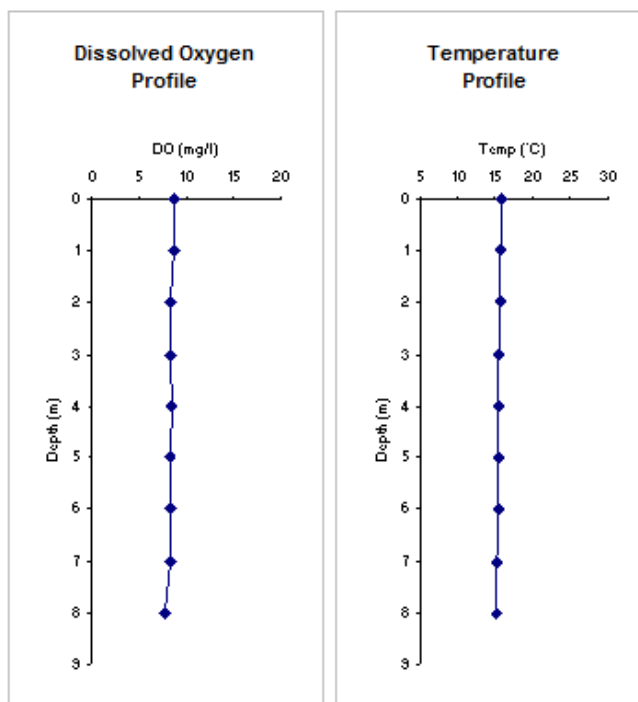
Depth (m)	DO (mg/l)	Temp (°C)
0	8.8	16
1	8.72	15.7
2	8.41	15.6
3	8.34	15.5
4	8.51	15.5
5	8.38	15.5
6	8.36	15.4
7	8.27	15.3
8	7.8	15.3

Figure 31. Dissolved oxygen and temperature profiles at Llyn Fanod (20/09/2016).

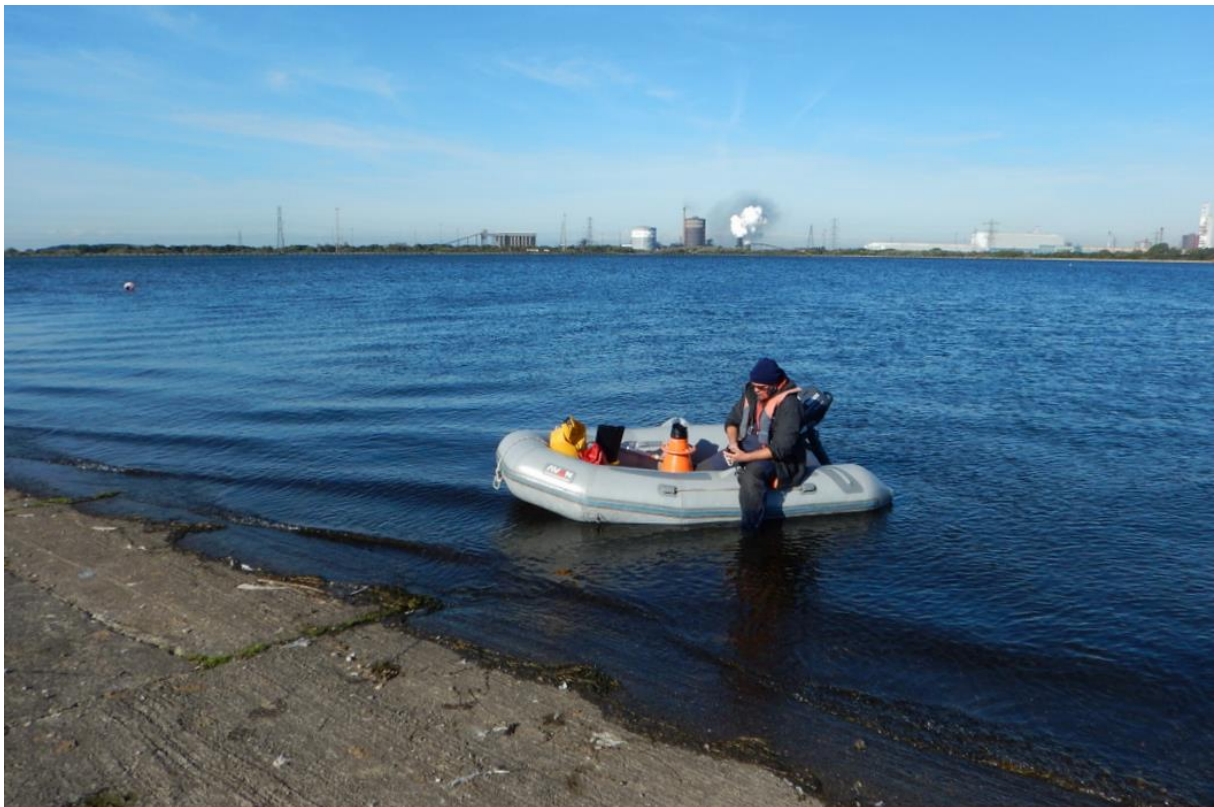
Figure 43. Eglwys Nunnydd Reservoir site photo; from the east shore looking north-west.

Eglwys Nunnydd Reservoir is a large (91 ha), shallow (max. depth 3.6 m), moderate alkalinity lowland reservoir located in Neath Port Talbot, Wales. The site was originally constructed as a supply reservoir for the adjacent Port Talbot steelworks. It is now also used for leisure activities and there is a sailing club on the east of the site as well as shore angling. The M4 motorway runs close to the east of the reservoir

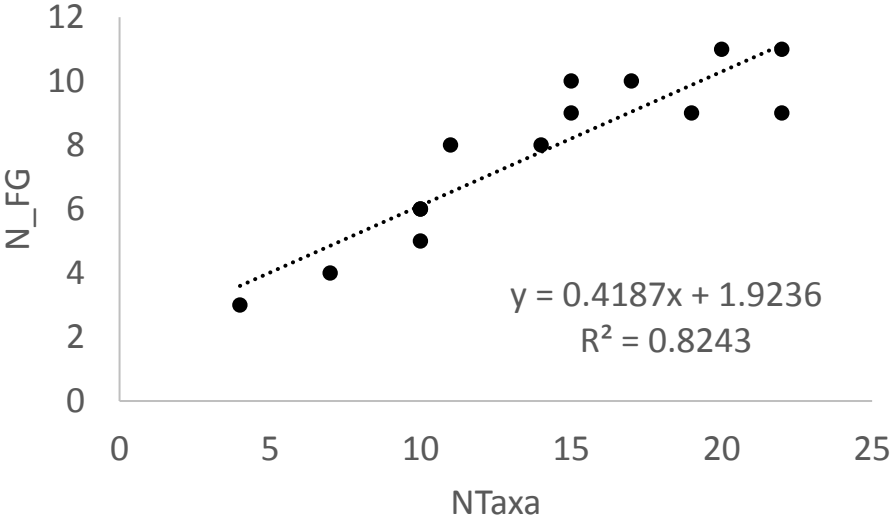
Figure 45 Relationship between NTaxa and N\_FG for the 14 lakes surveyed

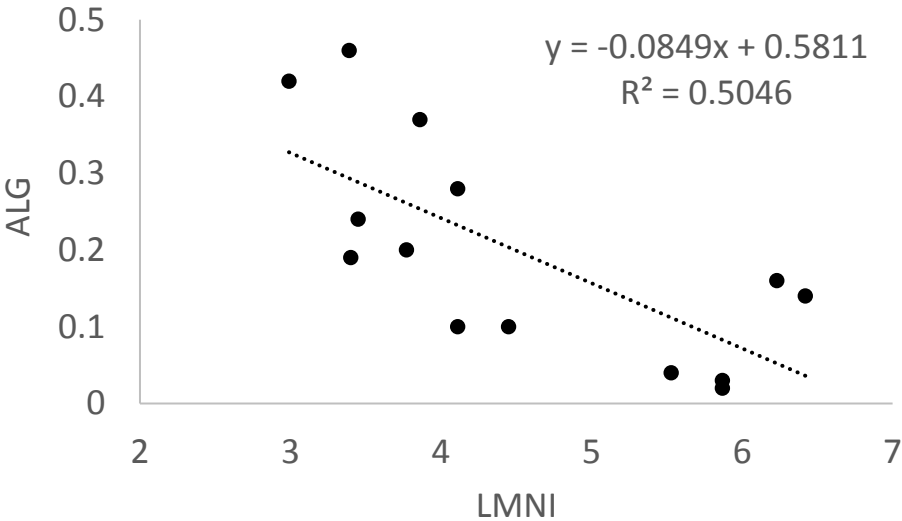
by the tendency of upland lakes with a high proportion of rocky substrates to support higher filamentous algal cover, but nonetheless supports the low weighting given to the ALG metric in the LEAFPACS tool.

Figure 46 Relationship between LMNI and ALG for the 14 lakes surveyed.
