Llyn Tegid Reservoir Safety Improvements

Bat Roost Potential Survey Report

October 2018

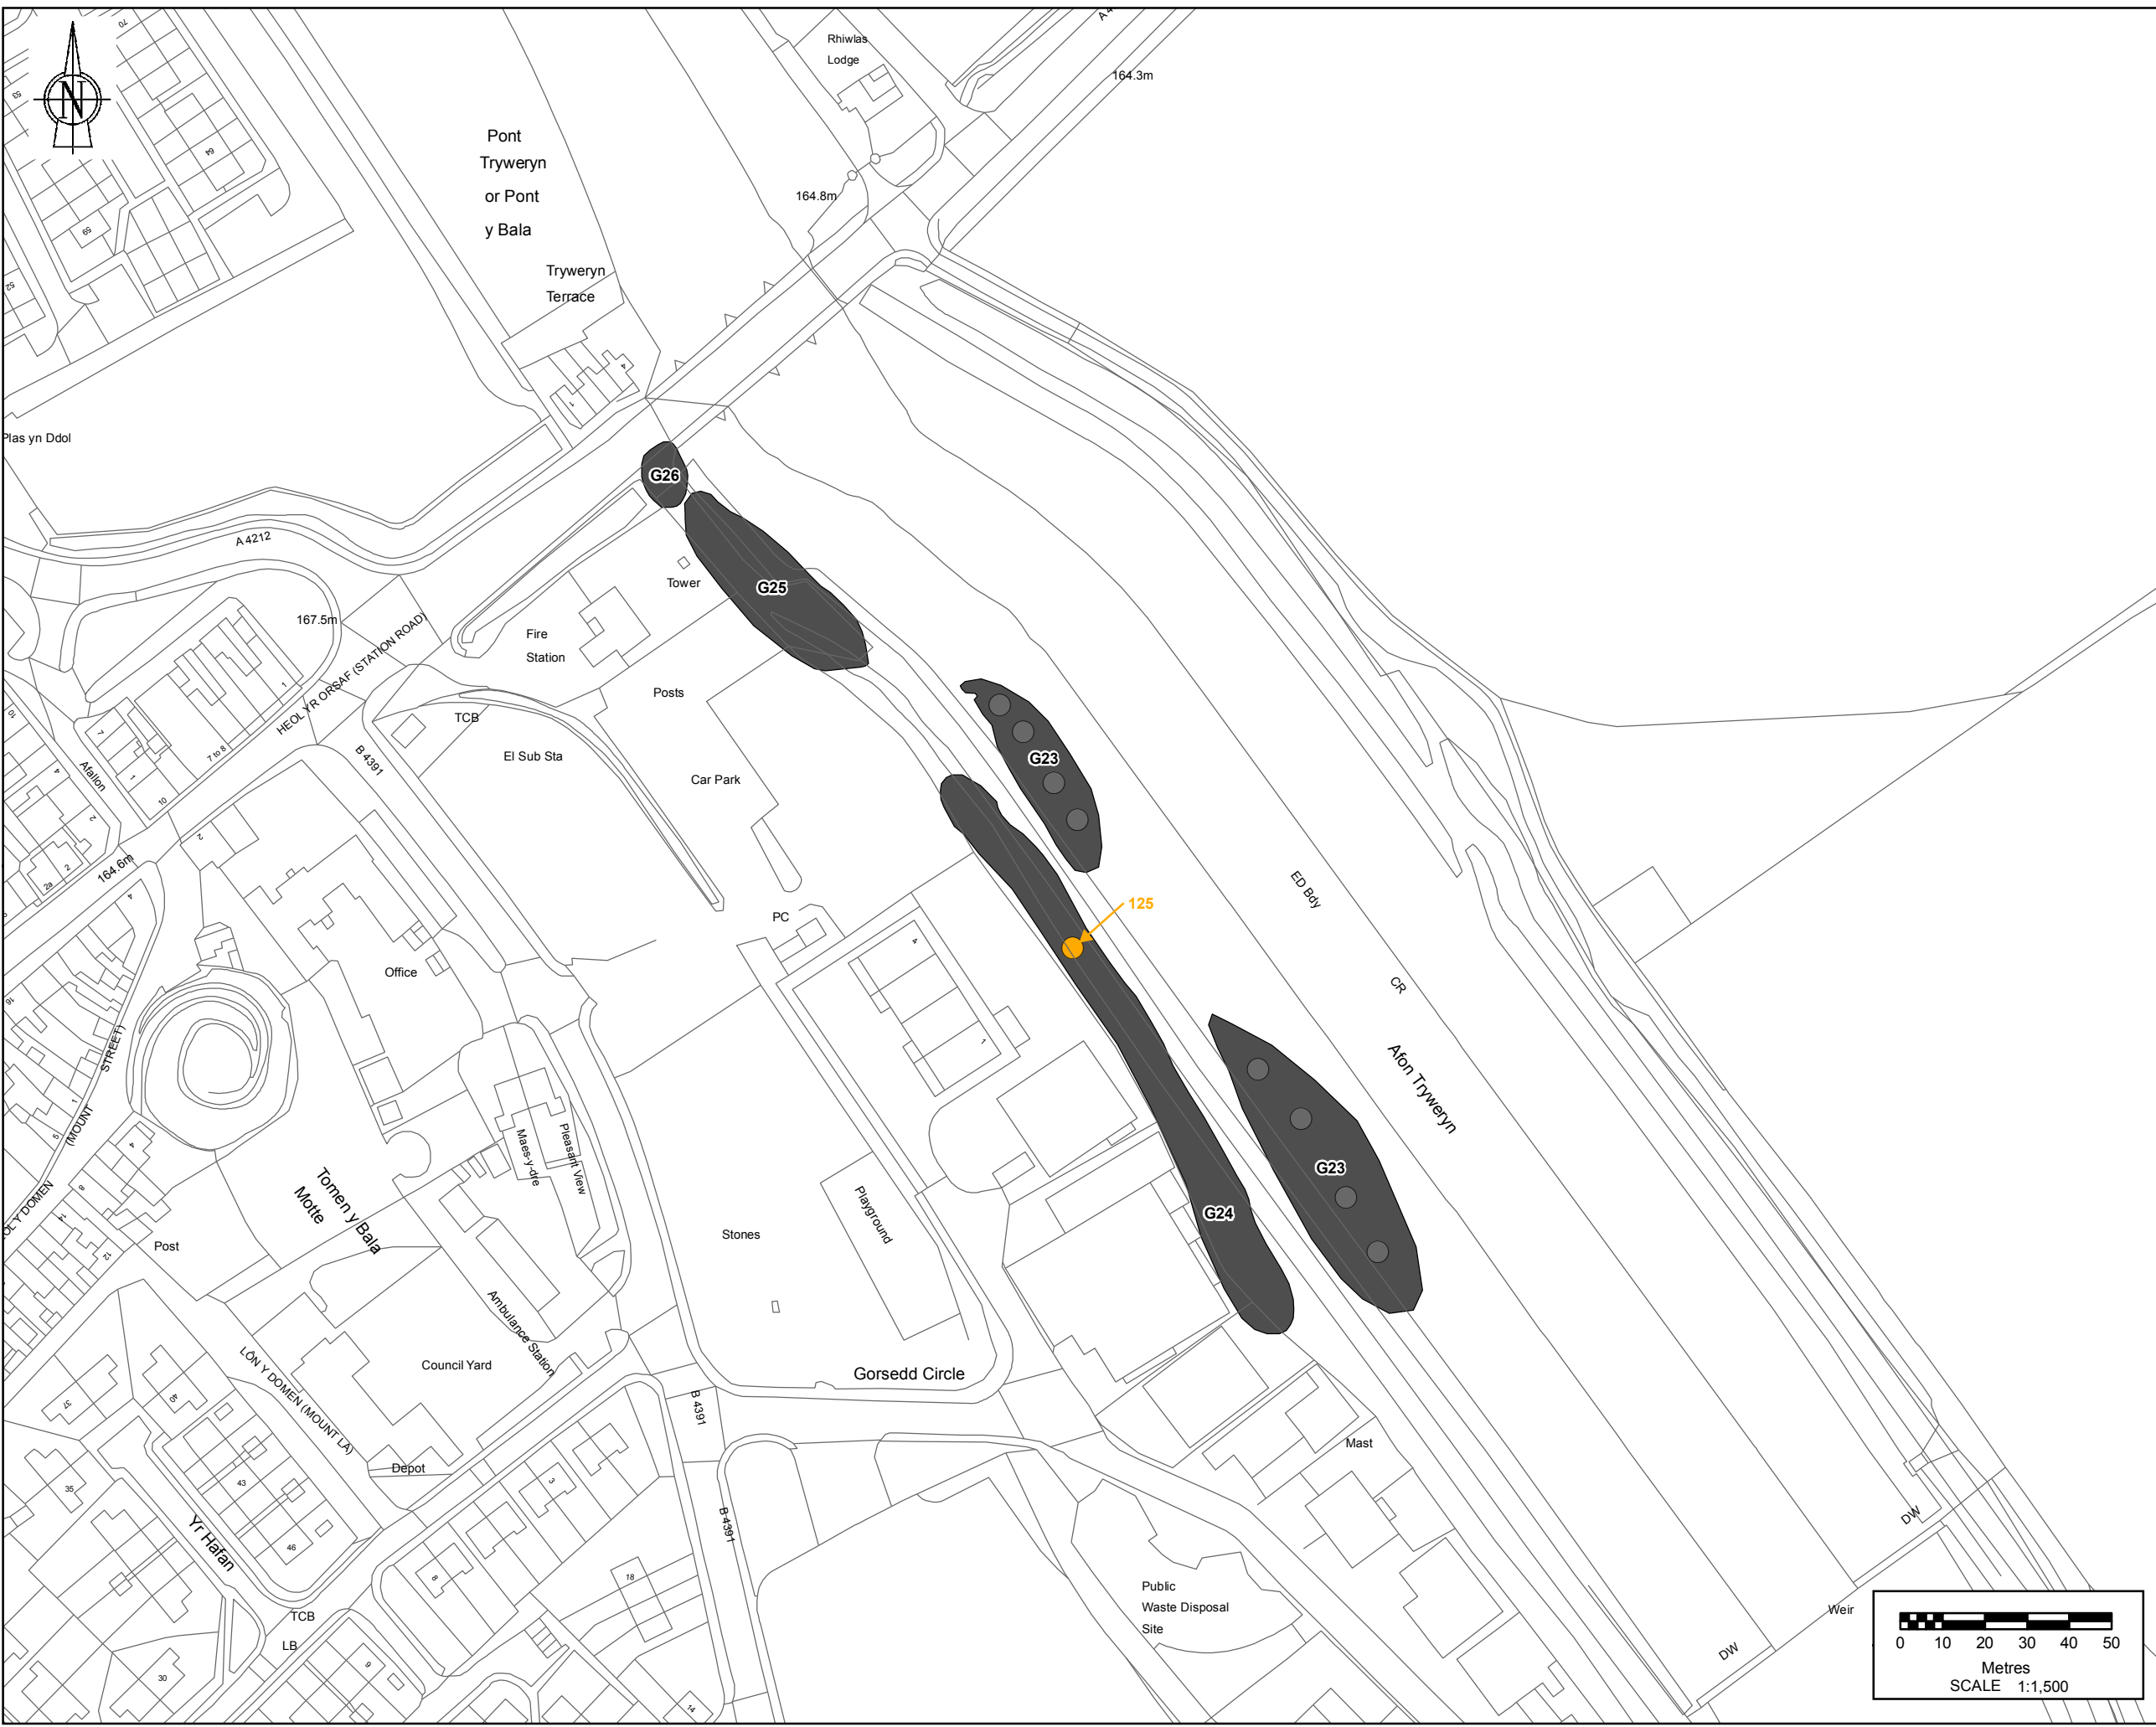
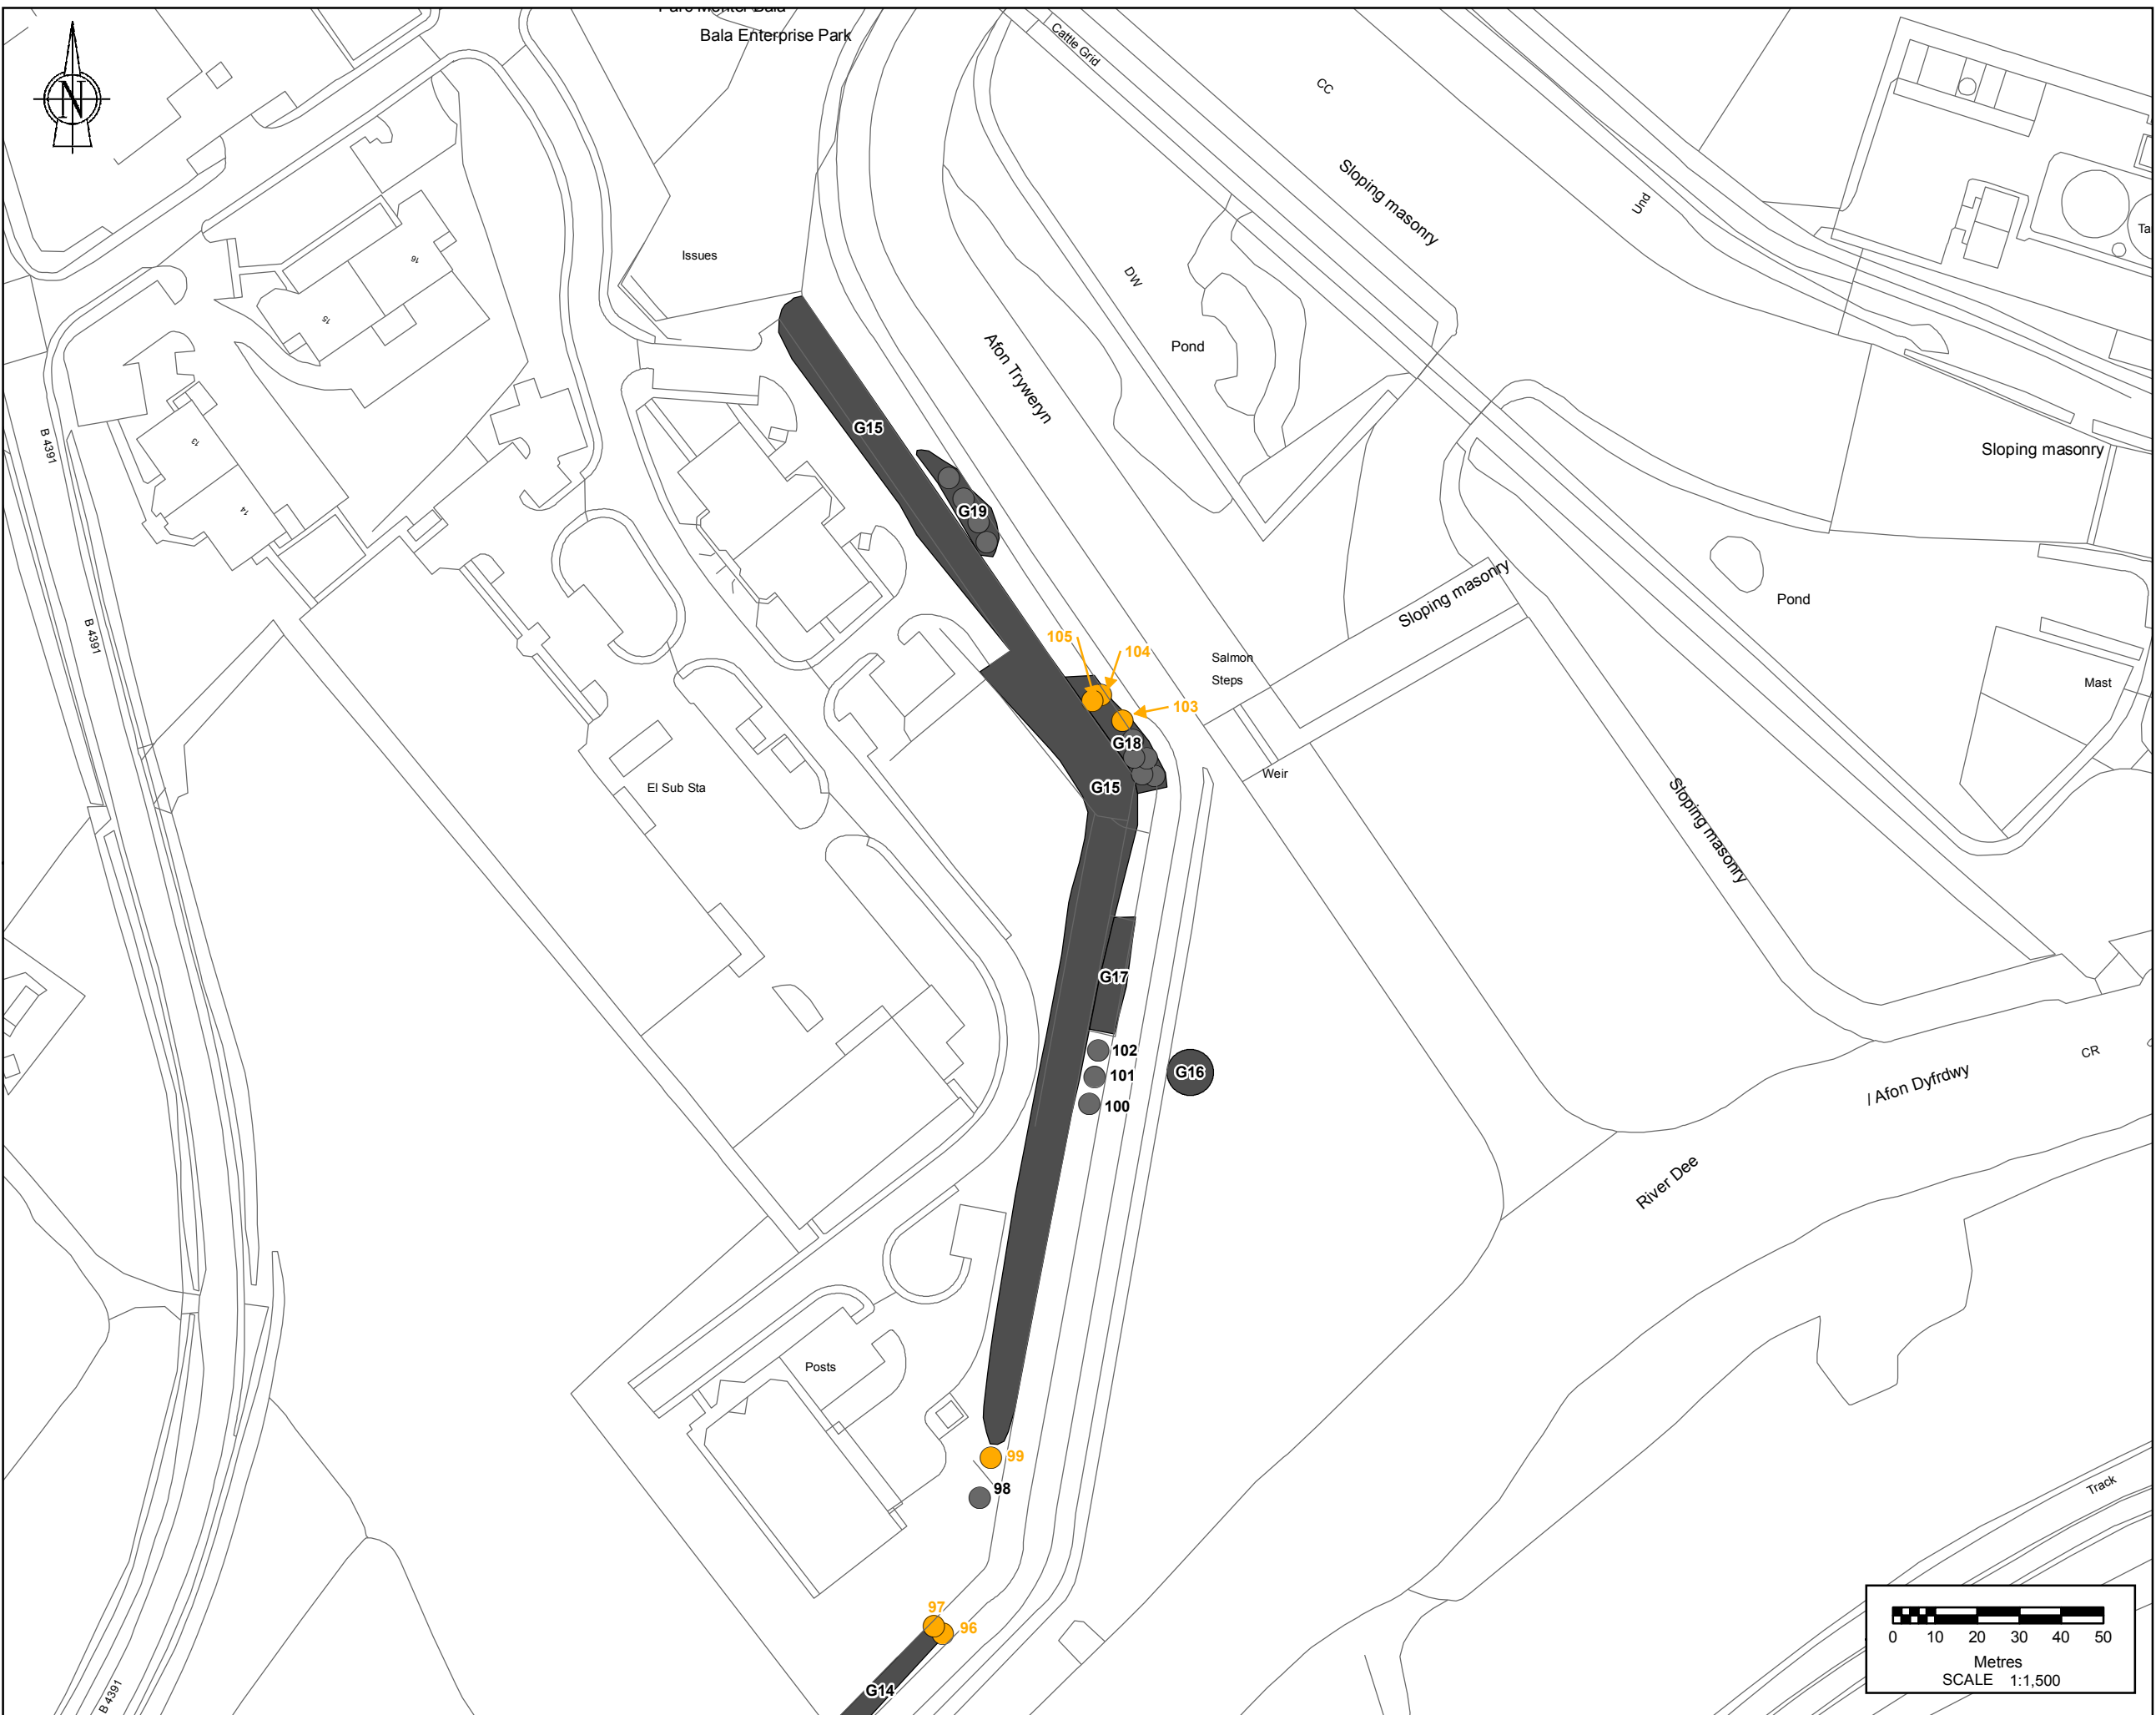
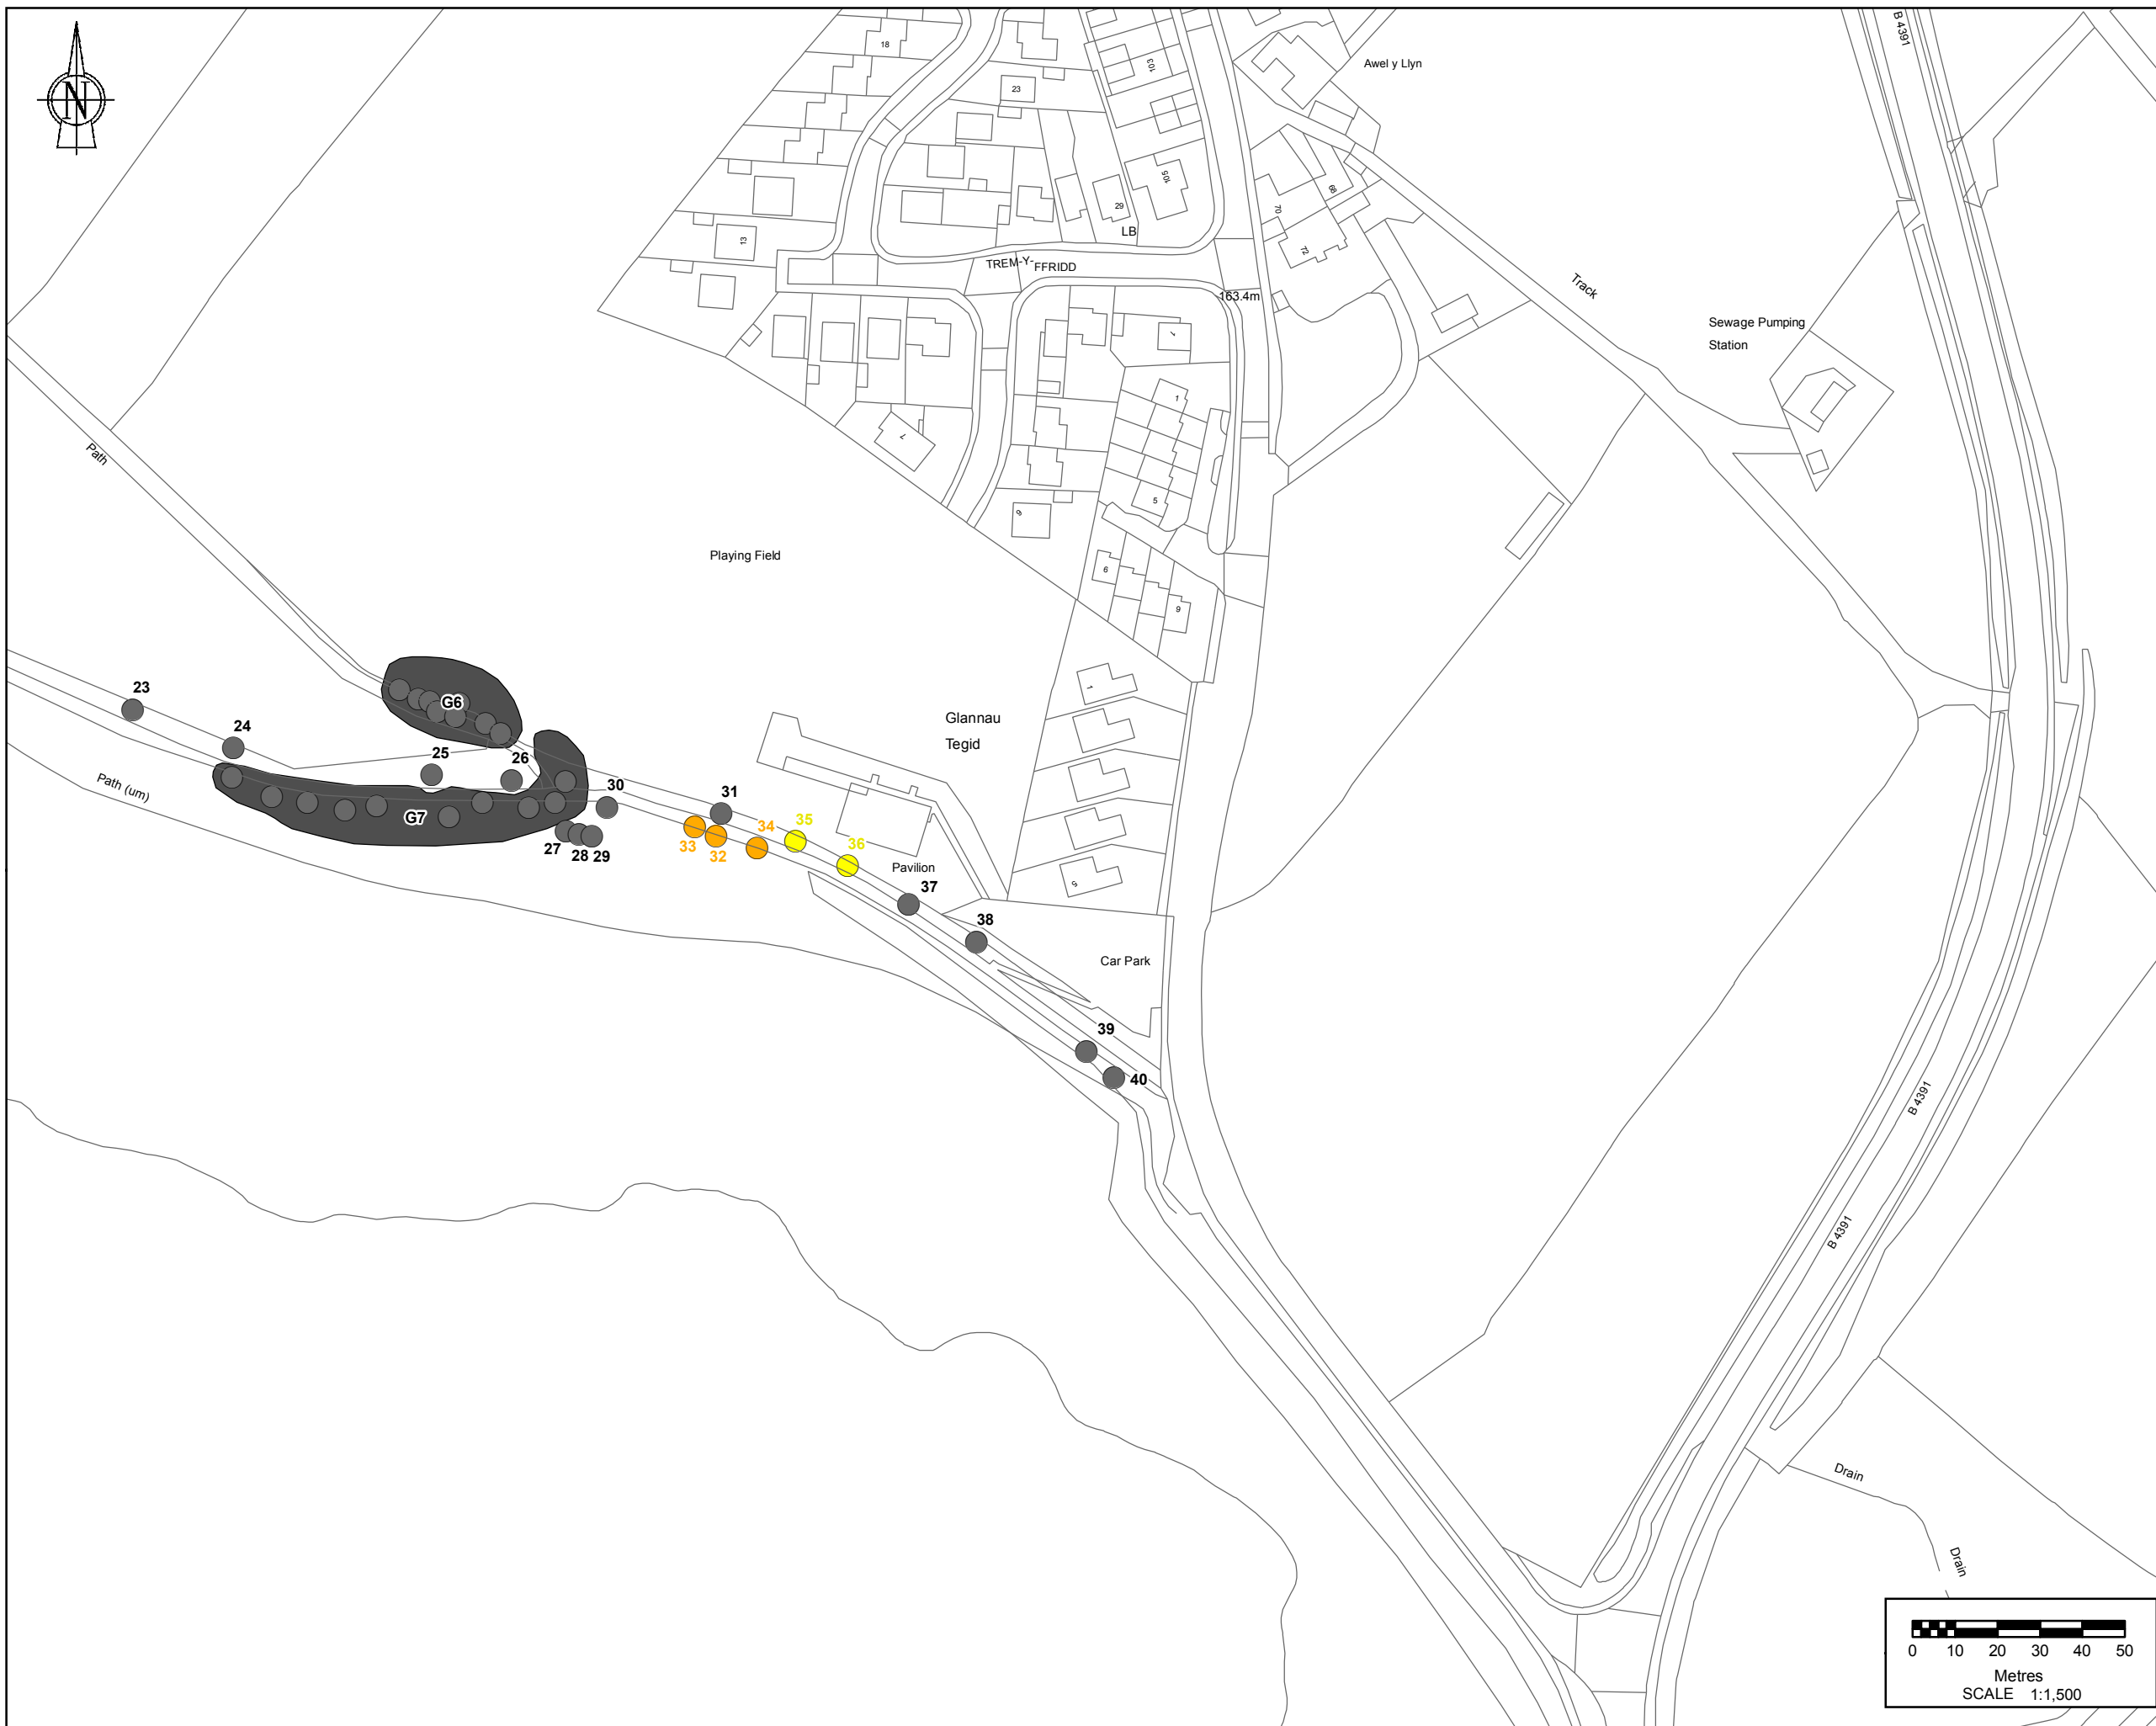
APPENDIX A: PRELIMINARY BAT GROUND INVESTIATION PLAN

There are individual trees potentially subject to felling to enable the flood protection works within the survey area and an annotated diagram of these can be found in Appendix A.

Details for each tree can be found in Appendix B and tree locations are shown in Appendix A.

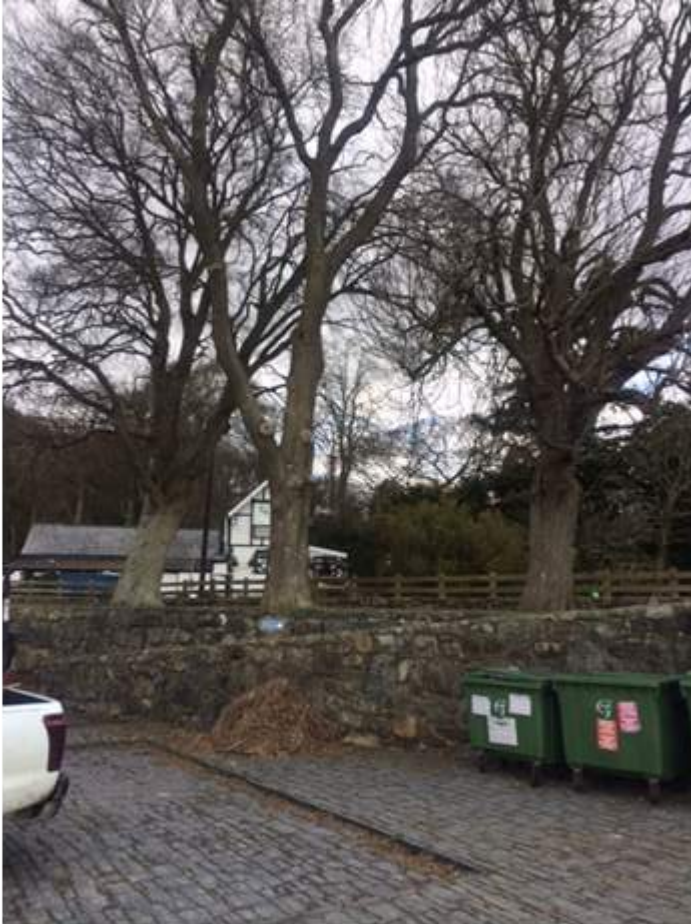
Tree 4 and 5 (middle and right)

| Tree Ref | Tree species | DB H (m) | Height (m) | Age (OM / M/ EM/ Y) | Description of Feature | | | | | | | Bats/evidence present Describe | Bat Roost Potential | | | | Proposed Action (Potentially removing/Not removing) | Survey recommendation |
|---|---|---|---|---|---|---|---|---|---|---|---|---|---|---|---|---|---|--|
| 4 | Unknown | 1-1.5 | 10-12 | M | | X | | | | | | Two small sections of loose bark (8m) and possible cavity but couldn't see due to height. | | X | | | Potentially removing | Aerial inspection or emergence/re-entry (2 visits) May-September |

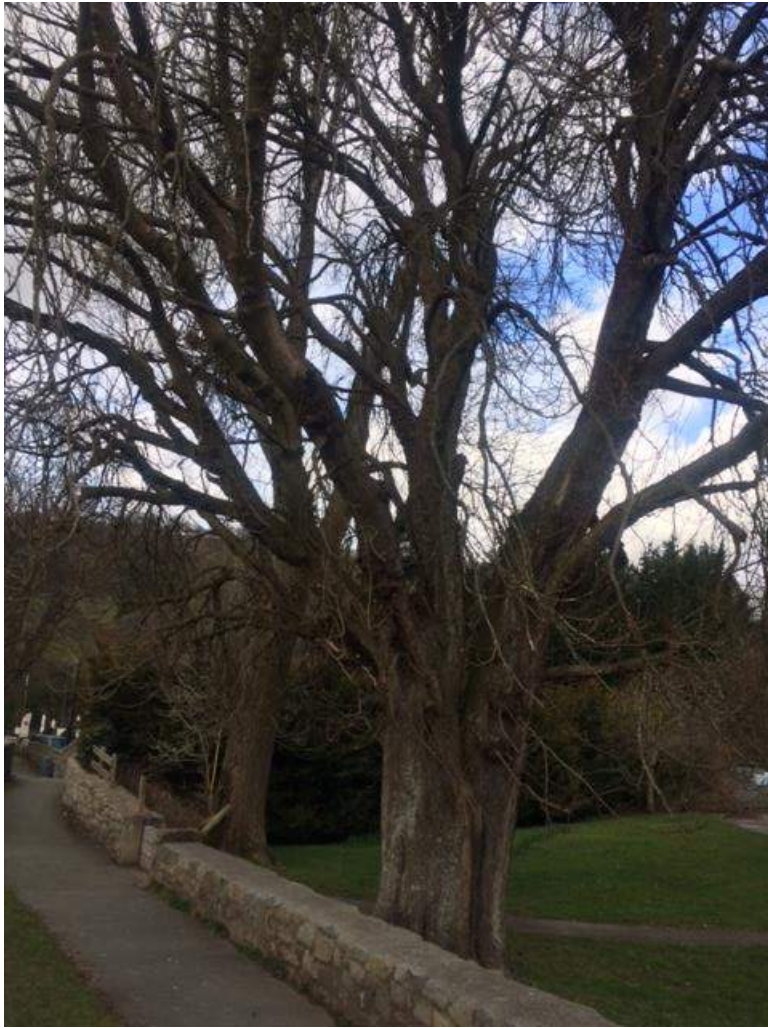
Tree 7/8

| Tree Ref | Tree species | DB H (m) | Height (m) | Age (OM / M/ EM/ Y) | Description of Feature | | | | | | | Bats/evidence present Describe | Bat Roost Potential | | | | Proposed Action (Potentially removing/Not removing) | Survey recommendation |
|---|---|---|---|---|---|---|---|---|---|---|---|---|---|---|---|---|---|---|
| 8 | Horse Chestnut | 1-1.5 | 10 | M | X | X | | | | | | Cracks fissures and holes in several places (between 4-8m) | X | | | | Potentially removing | Aerial inspection or emergence/re-entry (3 visits) May-September |

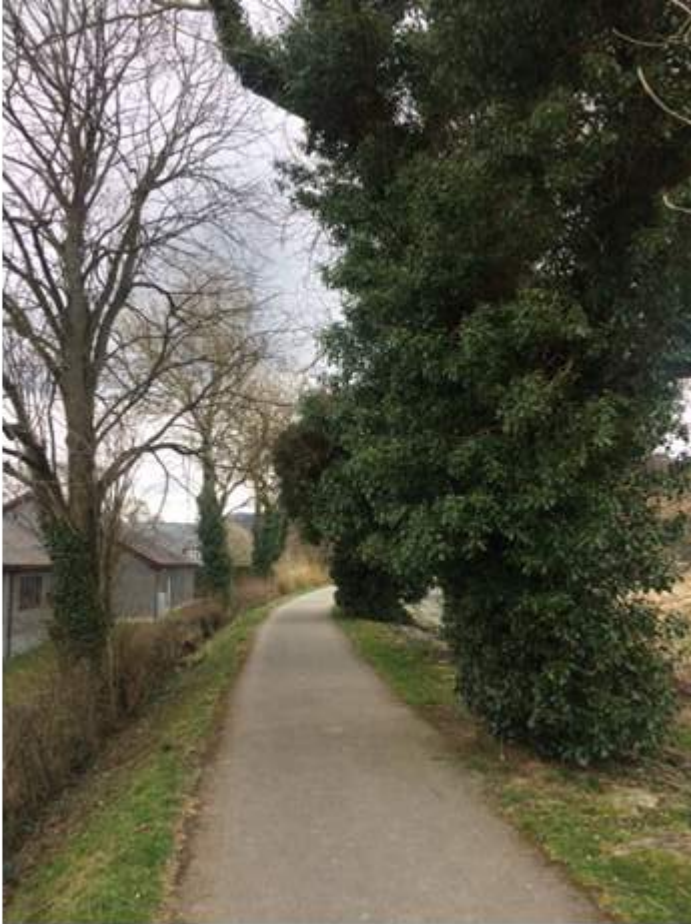
Tree 33/34/35 on right (although looks to be only 2 shown here). All similar covering of ivy.

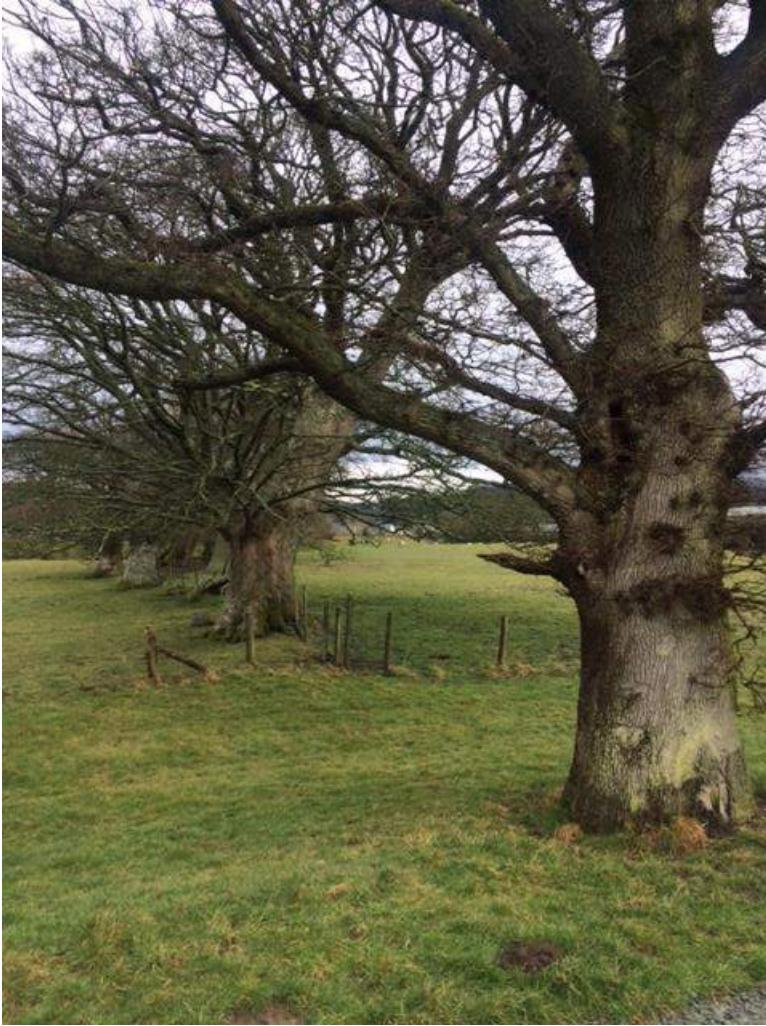
Tree 94, 95

| Tree Ref | Tree species | DB H (m) | Height (m) | Age (OM / M/ EM/ Y) | Description of Feature | | | | | | | Bats/evidence present Describe | Bat Roost Potential | | | | Proposed Action (Potentially removing/Not removing) | Survey recommendation |
|---|---|---|---|---|---|---|---|---|---|---|---|--|---|---|---|---|---|--|
| 95 | Sycamore | 2 | 12 | M | | X | | | | | | Some loose bark and small holes present at | | X | | | Potentially removing | Aerial inspection or emergence/re-entry (2 visits) May-September |

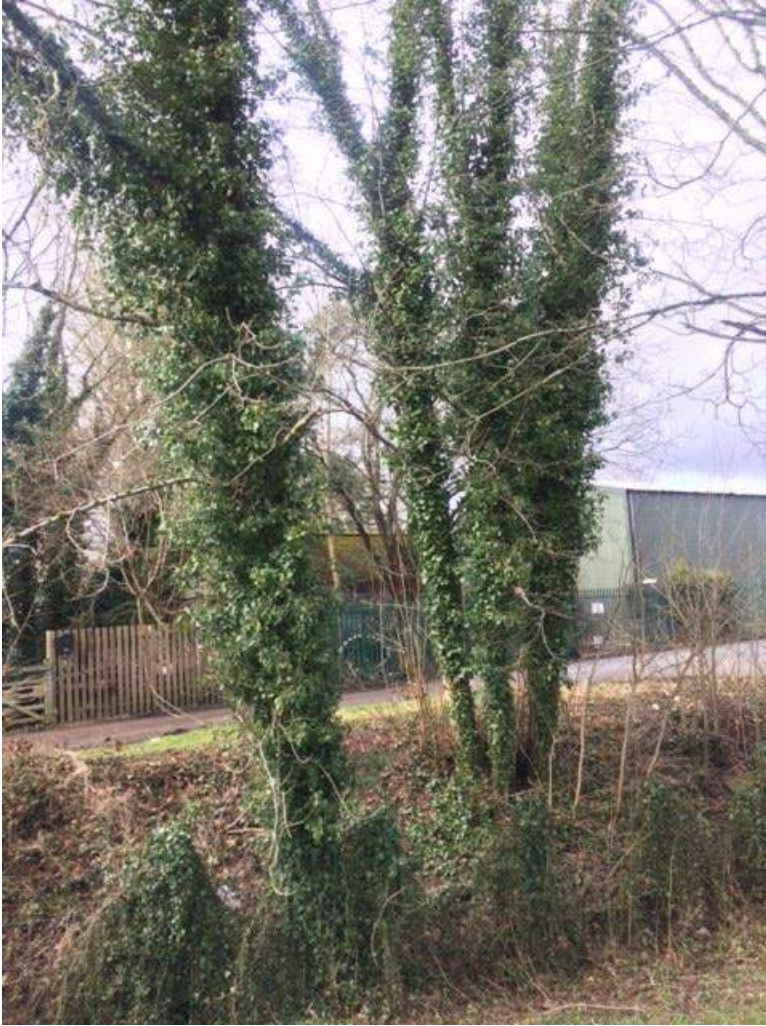
Tree 115/116 (116 surveyed as one tree)

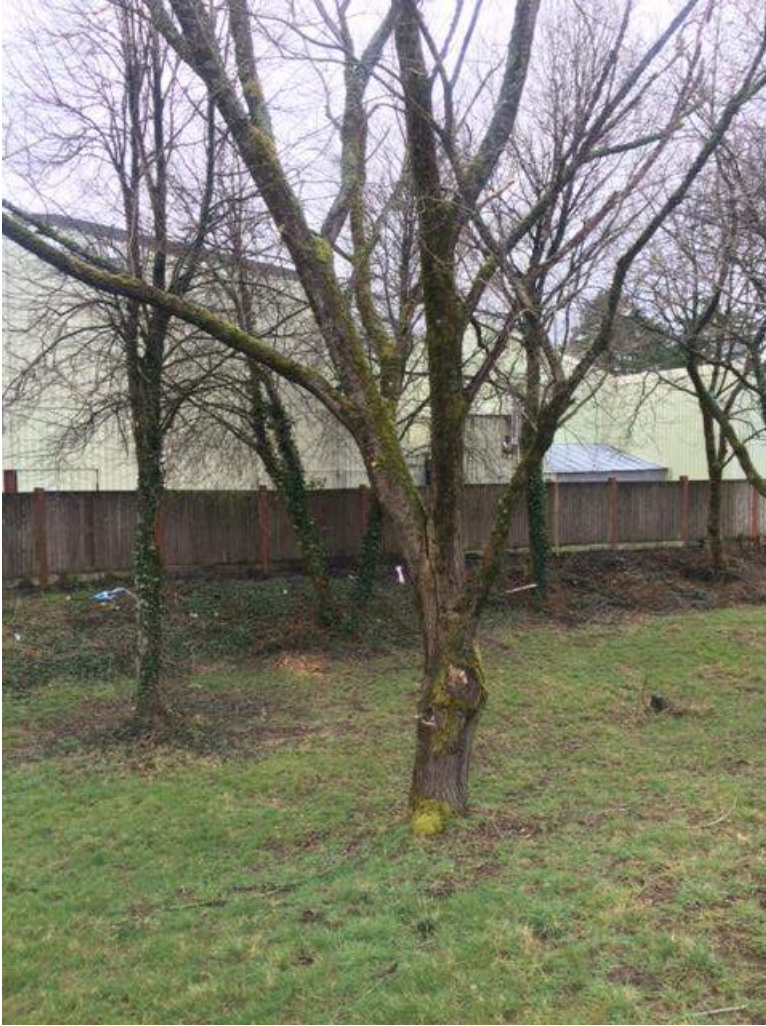
Tree 125 in foreground with split evident.

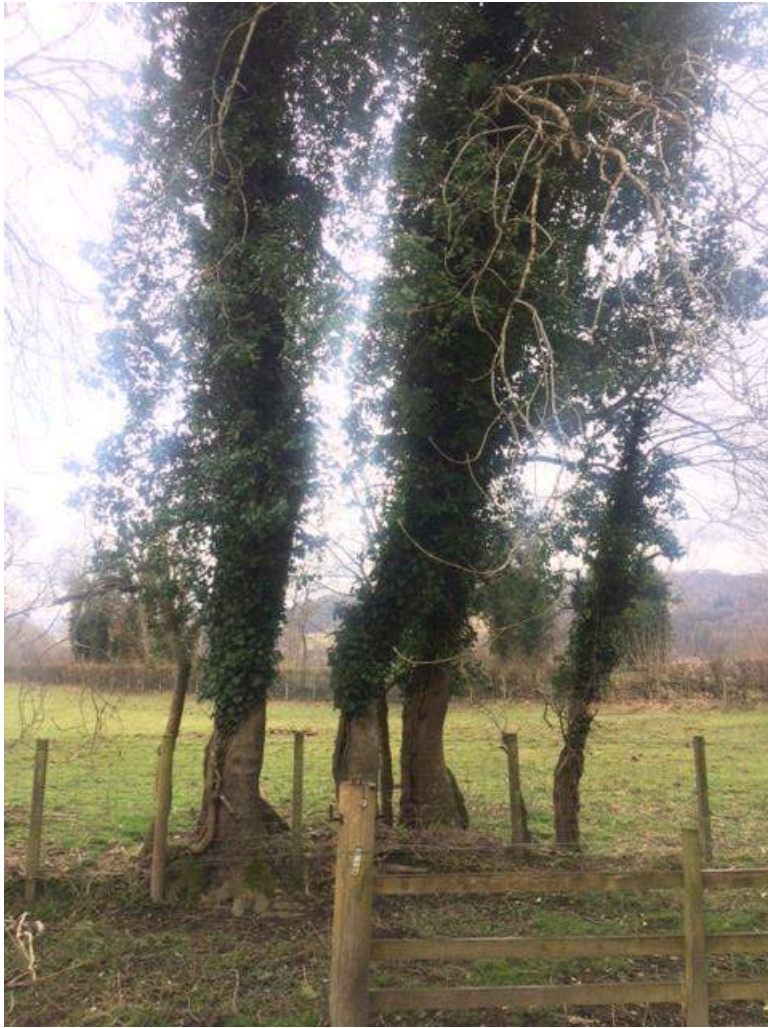
Tree 53/54/55. Three large trees in the centre.
